# Waxwing Tree Specialists

## Forest Management Plan

Prepared For: Wilderness Property Owner's Association

Date of Assessment: 4/21/2025-4/25/2025

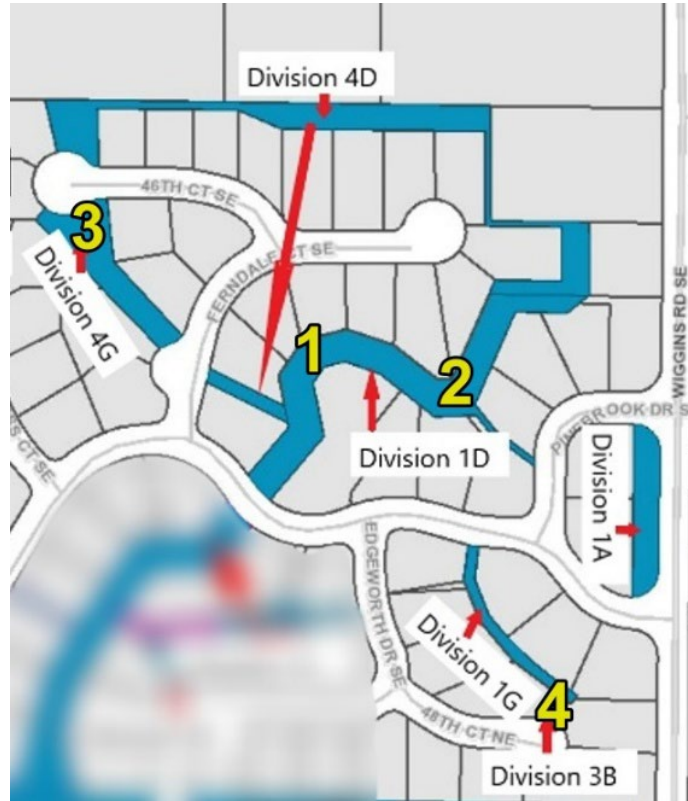
### Group 1:

**Additional Group 1 notes:** The area that runs east/west that is north of 46<sup>th</sup> Ct SE is likely not a reasonable restoration area. Blackberry was observed in this area, but encroachment of fences and private landscapes made access very difficult and property boundaries very unclear. Observed declining alders adjacent to this space appear to be originating on the adjacent forested spaces to the north and do not appear to currently pose a significant risk to WPOA properties.

1. **Plant:** Reforest declining maple stand with mixed overstory and diverse midstory/understory species. (West of Creek, ~200' span between Ferndale entrance and 4526 Ferndale Ct)
  - Overstory:
    - Western redcedar (*Thuja plicata*) × 3
    - Lodgepole pine (*Pinus contorta*) × 3 - *locate in sunniest gaps*
    - Pacific dogwood (*Cornus nutallii*) × 3
  - Midstory:
    - Vine maple (*Acer circinatum*) × 4
    - Cascara (*Rhamnus purshiana*) × 3
    - Serviceberry (*Amelanchier alnifolia*) × 3
    - Beaked hazelnut (*Corylus cornuta*) × 3
    - Red elderberry (*Sambucus racemosa*) × 5
  - Groundcover/Shrub Layer:
    - Thimbleberry (*Rubus parviflorus*) × 10 — *focus along edges*
    - Nootka rose (*Rosa nutkana*) × 5
    - Snowberry (*Symphoricarpos albus*) × 10

2. **Plant:** Install shade-tolerant mid and understory natives to suppress yellow archangel (*Lamium*):

3. **Invasive species removal:** Remove establishing blackberry.

**Plant:** Re-establish overstory and midstory. Remove select coarse woody debris to create planting pockets. Groundcover planting will be limited due to log density.

4. **Plant:** Clear declining bigleaf maple saplings at 48th Ct SE entrance and replant with resilient species. Additionally plant mid and understory species in this Division, particularly behind 3513 Wilderness Dr SE:

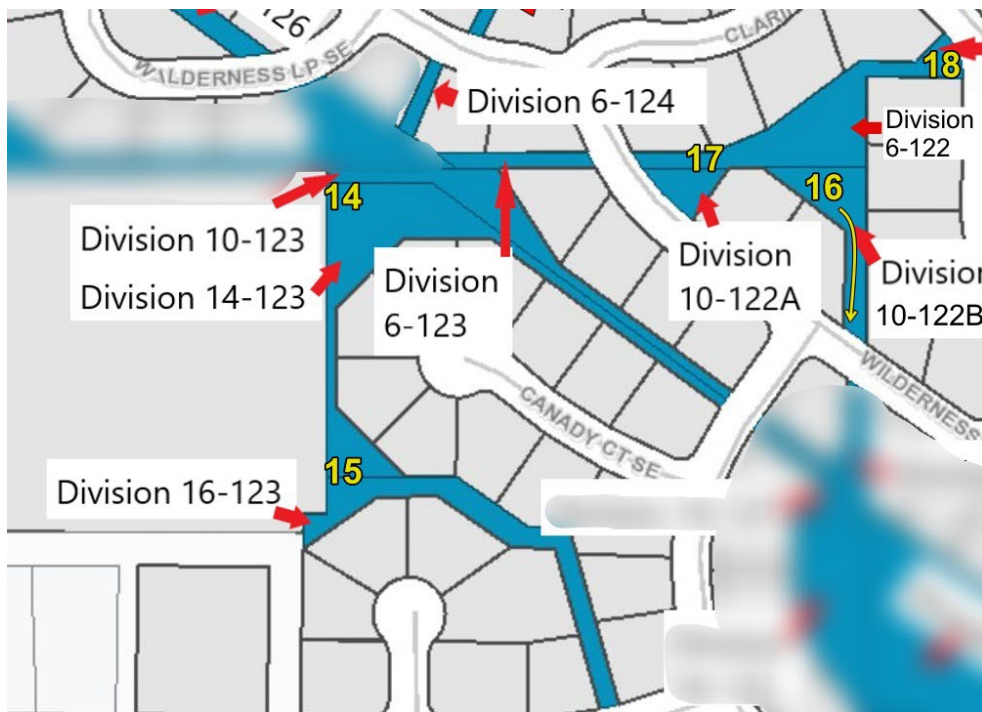
#### Group 4:

**Additional Group 4 Notes:** This group is very entrenched with invasive species and often abuts non WPOA managed spaces that are also heavily covered with invasives. Additionally, many areas have unclear property boundaries and have been incorporated into private landscapes, often with private cherry laurel hedgerows that are growing into the WPOA space. This may make invasive species eradication and replanting particularly challenging.

**14. Invasive species removal:** Remove very entrenched LARGE blackberry patch.

**Plant:** Re-establish extensive blackberry removal area with direct sun tolerant species:

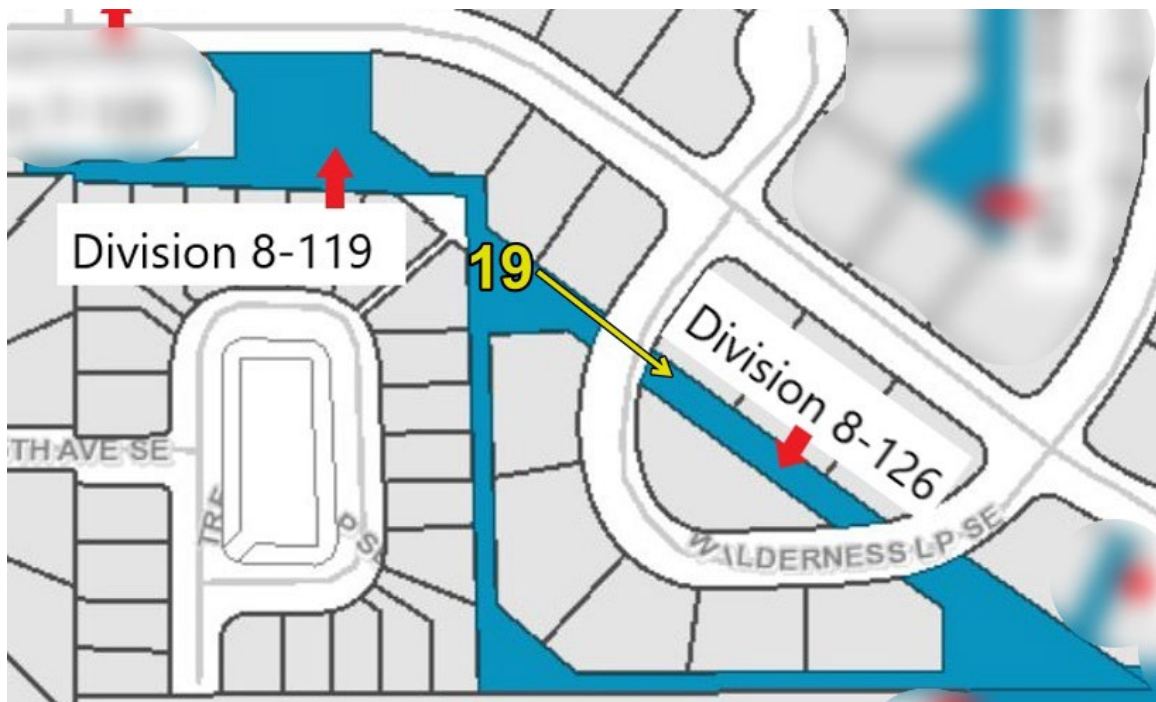
#### Group 5:

**Additional Group 5 Notes:** The area behind 3031 Wilderness Lp SE (The southern border of Division 8-126) is very hard to access and is entrenched in blackberry. It abuts an adjacent property to the south that is not WPOA owned and is also heavily entrenched in invasives. This might not be a realistic invasive species control area.

**19. Invasive species removal:** Very entrenched blackberry patch lining trail – remove

**Plant:** plant along trail to suppress blackberry. Consider options that encourage community interaction and involvement such as: native wildflowers, native and non-invasive edible landscape options like currant, strawberry patches, elderberries, blueberries, fruit trees. This could be a great pollinator/edible native landscape area.

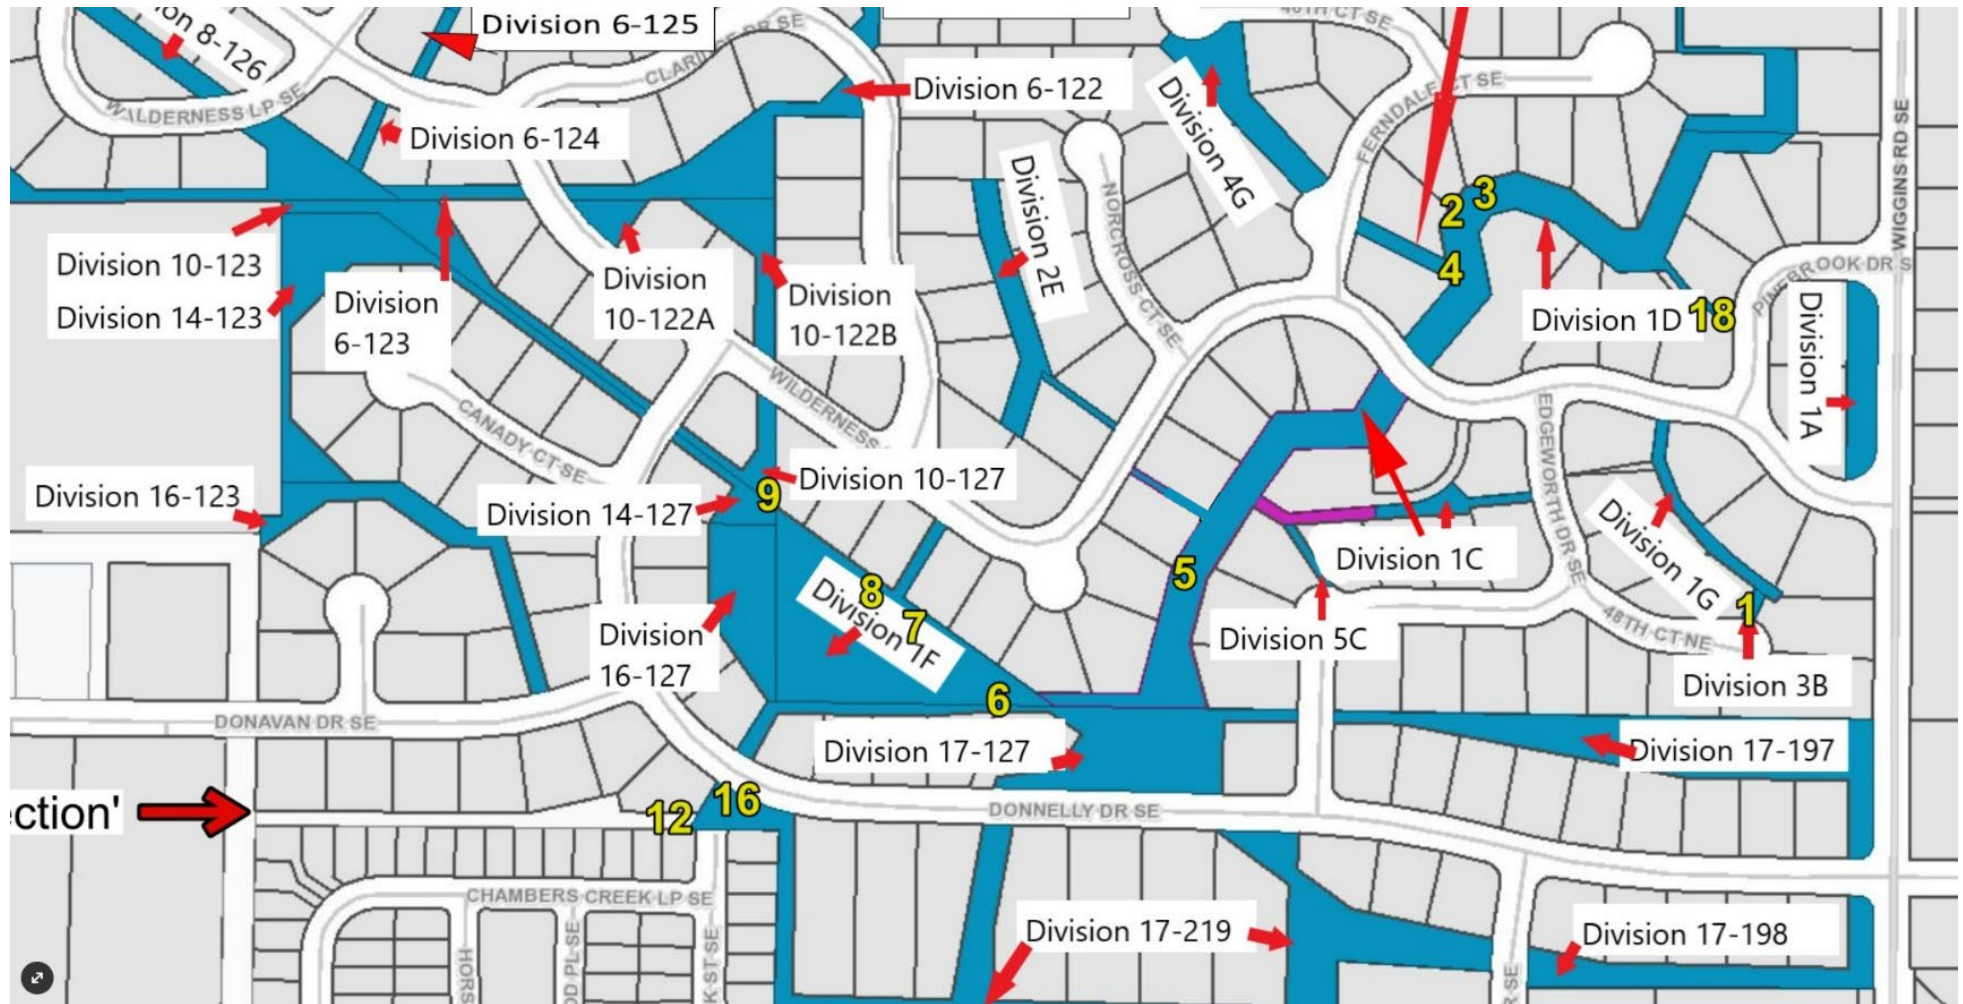
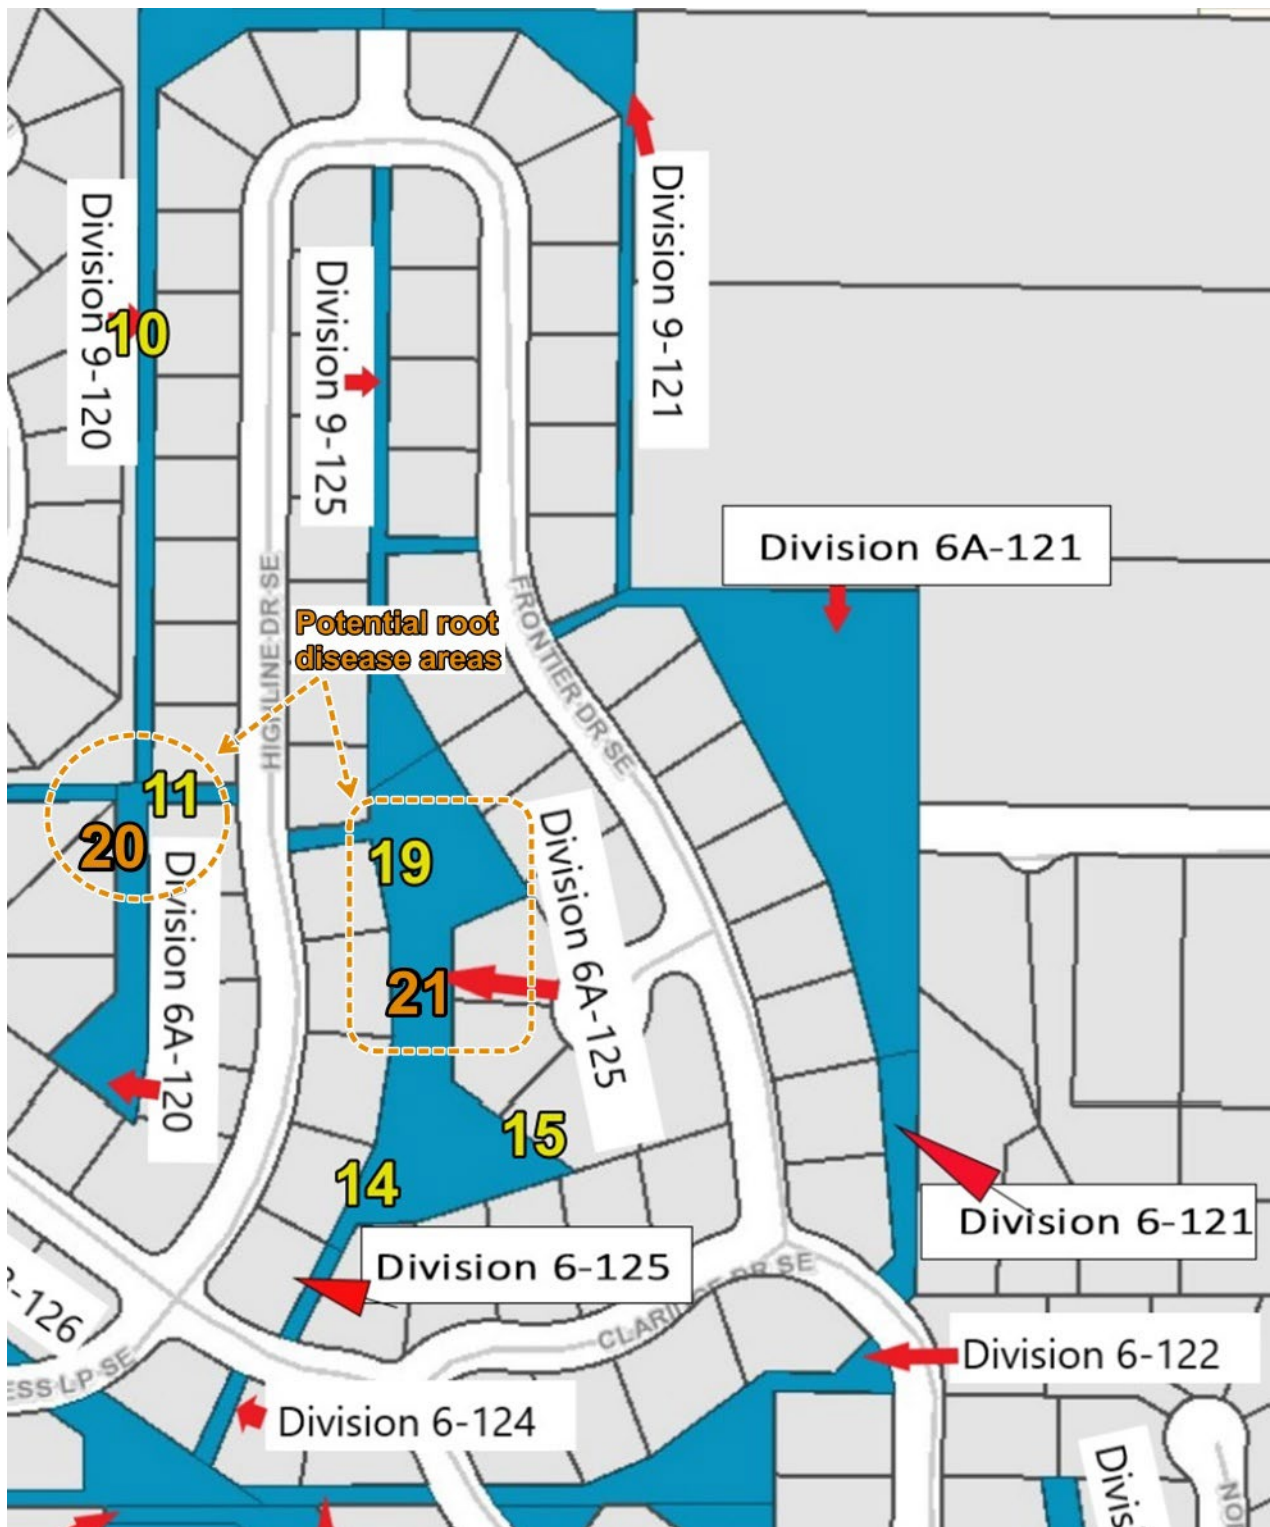
### Maps of Trees Recommended for Mitigation

Tree ID #	Species	Diameter at Breast Height (in)	Height (ft)	Condition	Conditions of concern	Risk/Priority	targets	Recommendations
1	Red alder	14	60	Dead	Dead tree	Moderate	Adjacent property	Remove
2	Bigleaf maple	15+13	65	Poor	Extensive basal decay (K. deusta)	Moderate	Adjacent property	Remove
3	Oregon ash	27	90	Poor	Extensive basal and trunk decay	Moderate	Adjacent property	Remove
4	Bigleaf maple	Large multi	90	Poor	Extensive basal and trunk decay (K. deusta)	Moderate	Multiple adjacent properties	Reduce 26" and 22" stems to habitat snags
5	Bigleaf maple	45+18+20	75	Poor	Extensive basal decay (K. deusta)	Moderate	shed	Remove stem growing over shed. The remainder of the tree is not in striking distance/direction of a concerning target
6	Western redcedar	Large multi	75	Good	Codominant stems with inclusions	Low	Residence	Consider 8T dynamic Cobra cable installation in south facing stem overhanging private property

7	Bigleaf maple	45	90	Fair	Some basal decay present (K. deusta)	Low	Residences	Consider Level 3 Resistograph reading to determine extent of basal decay
8	Bigleaf maple	56	90	Fair	Some basal decay present (K. deusta)	Low	Residences	Structurally prune to reduce weight on W/NW side of canopy. Consider Level 3 Resistograph reading to determine extent of basal decay
9	Bigleaf maple	25	75	Poor	Extensive basal decay (K. deusta)	Moderate	Residence	Remove – possibly on adjacent property
10	Douglas fir	28	90	Fair	Defect/wound on trunk	Moderate	Residence	Perform climbing inspection of defect to determine extent of decay. Retain and monitor or remove based on findings.

11	Douglas fir	28	90	Poor	Declining canopy/basal decay.	Moderate	Residences	Remove – increment borer sample indicates basal decay.
12	Western redcedar	40	130	Fair	Codominant stem with inclusion	Low	Residences	Consider 8T dynamic Cobra cable installation
13	Lodgepole pine	42	45	Dead	Dead tree	Low	Street	Remove (May be removed by Conservation corps 2025)
14	Western hemlock	33	75	Very poor	Declining canopy	Moderate	Residence	Remove
15	Western hemlock	23	65	Dead	Dead tree	Moderate	Multiple Residences	Remove – (possibly on private property)
16	Red alder	24	60	Poor	Declining (phytophthora on trunk)	Moderate	Street and residence	Remove
17	Western redcedar	30		Good	clearance issue	Low	Residence	Canopy encroaching on roof of adjacent residence—consider clearance pruning
18	Western hemlock	15	60	Dead	Dead tree	Moderate	Multiple Residences	remove
19	Douglas fir	29	130	Poor	Declining canopy, possible root disease issue.	Moderate	Multiple Residences	Remove

20	Douglas fir	Multiple			Declining canopies			Perform Level 3 (Advanced) Tree Risk Assessment on mature Douglas-fir trees located near tree #11. Use Resistograph testing or equivalent methods to evaluate internal decay.
21	Douglas fir	Multiple			Declining canopies			Perform Level 3 (Advanced) Tree Risk Assessment on mature Douglas-fir trees located behind 4501 Frontier Ct SE and near tree #19 in section 6A-125. Use Resistograph testing or equivalent methods to evaluate internal decay.
